**DEPARTMENT OF TRANSPORTATION**

Contract #: 04-0120F4Cty: SF/ALA Rte: 80 PM: 13.2/13.9File #: xx.28**WELDING INSPECTION REPORT****Resident Engineer:**Siegenthaler, Peter**Address:** 333 Burma Road**City:** Oakland, CA 94607**Report No:** WIR-022581**Date Inspected:** 13-Apr-2011**Project Name:** SAS Superstructure**OSM Arrival Time:** 700**Prime Contractor:** American Bridge/Fluor Enterprises, a JV**OSM Departure Time:** 1900**Contractor:** Zhenhua Port Machinery Company, Ltd (ZPMC), Changxing Island **Location:** Shanghai China**CWI Name:** Mr. Liu Huajie**CWI Present:** Yes No**Inspected CWI report:** Yes No N/A**Rod Oven in Use:** Yes No N/A**Electrode to specification:** Yes No N/A**Weld Procedures Followed:** Yes No N/A**Qualified Welders:** Yes No N/A**Verified Joint Fit-up:** Yes No N/A**Approved Drawings:** Yes No N/A**Approved WPS:** Yes No N/A**Delayed / Cancelled:** Yes No N/A**Bridge No:** 34-0006**Component:** OBG Trial Assembly**Summary of Items Observed:**

## WELDING INSPECTION REPORT

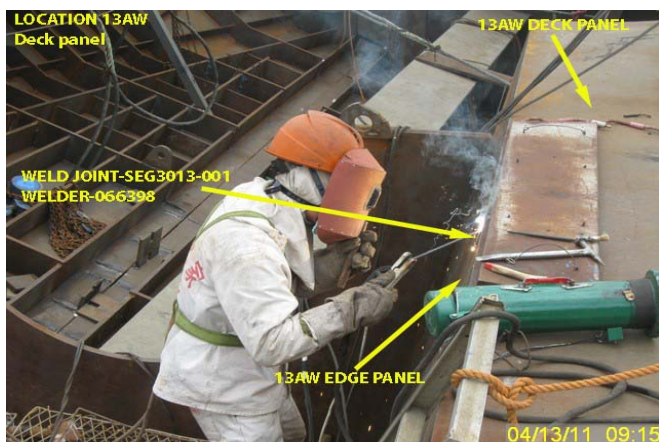
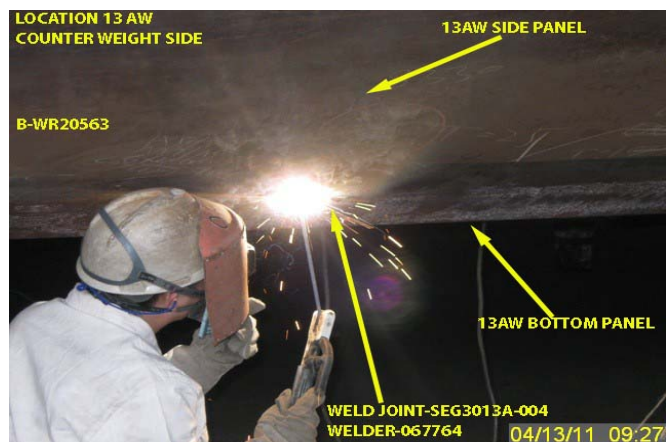
Trial Assembly:-

Shielded Metal Arc (SMAW) welding of Weld Joint SP3025-017-145 (Cross Beam(CB)#17 Side Panel to Cable Ring weld ), and Welder is identified as 044504; ZPMC Quality Control (QC) is identified as Mr. Li Yang, The welding variables appeared to comply with the Applicable WPS-B-P-2114-FCM-1.

Shielded Metal Arc (SMAW) welding of Weld Joint SEG3013W-072(13AW Floor beam to Stiffener weld ), and Critical Welding Repair Report(CWR)B-CWR2875,Welder is identified as 205098; ZPMC Quality Control (QC) is identified as Mr. Shen Jian Bo, The welding variables appeared to comply with the Applicable WPS-345-SMAW-4G(4F)-FCM-Repair-1.

Shielded Metal Arc (SMAW) welding of Weld Joint SEG3013-001(13AW Deck panel to Edge panel weld,CW Side ), and Welder is identified as 066398; ZPMC Quality Control (QC) is identified as Mr. Shen Jian Bo, The welding variables appeared to comply with the Applicable WPS-B-P-2212-TC-U4b-FCM-1.

Shielded Metal Arc (SMAW) welding of Weld Joint SEG3013AA-016(13AW Floor beam to Edge panel weld,CB Side ), and Welder is identified as 047864; ZPMC Quality Control (QC) is identified as Mr. Shen Jian Bo, The welding variables appeared to comply with the Applicable WPS-B-P-2213-TC-U4b-FCM-1.

Shielded Metal Arc (SMAW) welding of Weld Joint SEG3013A-004 (13AW BP to SP Holdback weld, CB Side ), and Welding Repair Report(WR)B-WR20563, Welder is identified as 067764; ZPMC Quality Control (QC) is identified as Mr. Shen Jian Bo, The welding variables appeared to comply with the Applicable WPS-345-SMAW-4G(4F)FCM-Repair-1.

Shielded Metal Arc (SMAW) welding of Weld Joint SEG3014A-009(13BW BP to SP Holdback weld,CB Side ), and Welder is identified as 045213; ZPMC Quality Control (QC) is identified as Mr. Wang Xiang Pin, The welding variables appeared to comply with the Applicable WPS-B-P-2214-B-U2-FCM-1.

This QA Inspector performed MT of approximately 15% of the area previously tested and accepted by ZPMC Quality Control personnel. This QA Inspector generated a MT report for this date. The member is identified as OBG 12AW Z Runner Plate welds, the weld designations reviewed are as follows.

Unless otherwise noted, all work observed on this date appeared to be in general compliance with the applicable contract documents.
